**AVIATION TECHNOLOGY SERVICES:
PIPELINE LEAK DETECTION**

Final Report for the Period of August to November, 2006

Rocky Mountain Oilfield Testing Center (RMOTC)
Work performed under CRADA 2006-075

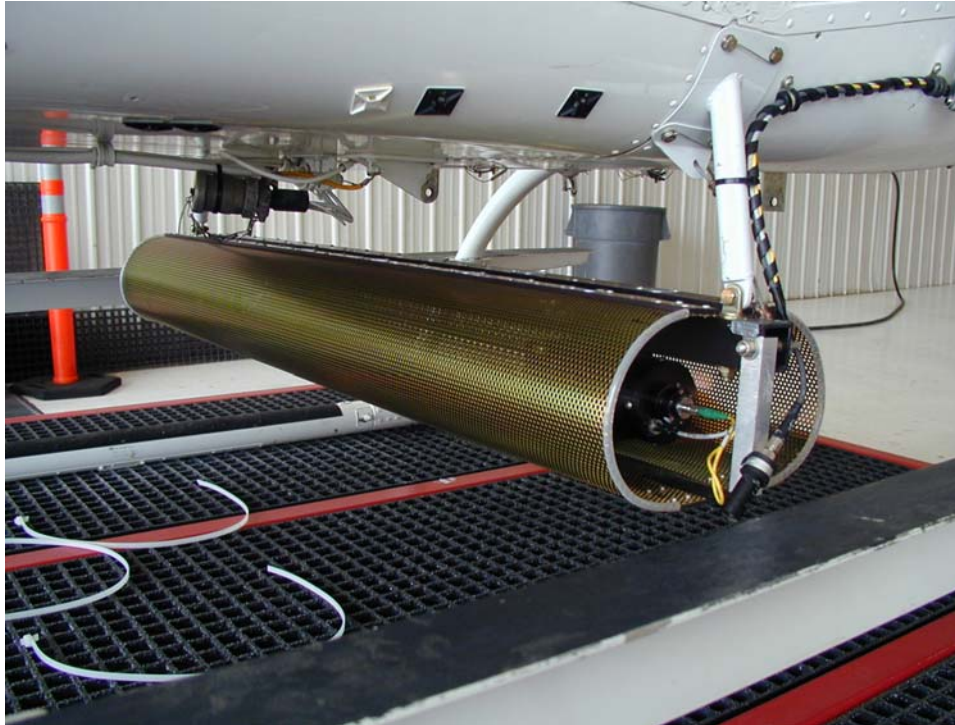
Figure 3. The Boreal laser sensor cell, without cover.

The ATS airborne leak detection service is based around the Boreal laser. The Boreal laser is a robust methane detection system, tuned to the absorption wave-length of the methane molecule and firing inside a porous, self-contained sensor cell attached near the bottom of the helicopter, Figure 3. Air passing through the laser cell is sampled over 300 times per second, accurately monitoring methane levels as low as one part per million (1 ppm). Laser accuracy is maintained through a patented self-calibration system which references its own pure methane sample every 3 to 6 seconds; thus increasing accuracy and eliminating background level drift. The laser samples the atmosphere over a pipeline and identifies rising methane plumes associated with leaks. At 50 mph and approximately 50 feet above ground level, the pilot follows a preloaded pipeline route using latitude and longitude points on a Global Positioning Satellite (GPS) receiver. Advantages to the system are that temperature changes, ground, and cloud conditions do not affect the performance of the Boreal laser. Excellent survey results are achieved in wind speeds up to 18 mph. To complete the airborne pipeline leak detection system, ATS uses a state of the art GPS directed mapping program linked to a color digital video and audio capture program that plots methane levels collected and records them to a hard drive. Post-survey analysis and archiving of the pipeline data can be viewed on the mapping program to visually review exact locations of problems such as right of way issues, exposed pipe,

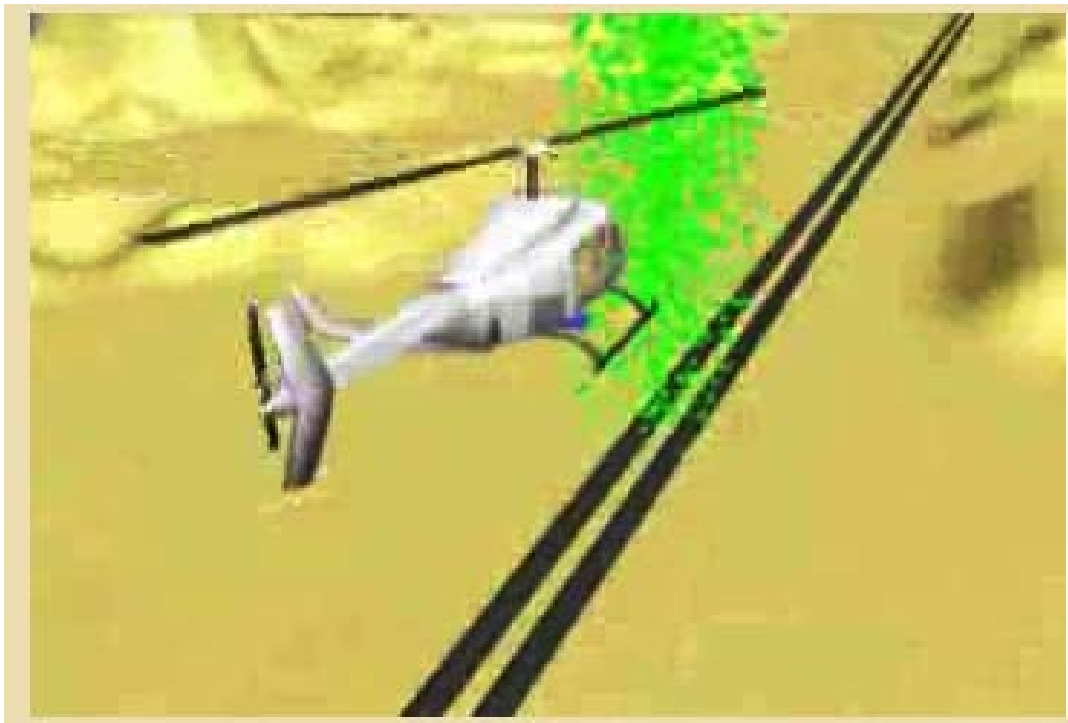
Figure 4. Simulation of ATS’s helicopter over a pipeline with the methane plume indicated in green.

ATS conducted a series of leak detection tests with its airborne laser methane detection system between September 12th and 14th, 2006. ATS flew their leak detection system over the pipeline each time the scenario was altered. To perform an impartial and controlled evaluation of ATS’s airborne laser leak detection system, ATS was required to provide an analysis of their testing results prior to RMOTC providing the actual leak data scenarios. ATS then reevaluated their results based on the actual data.

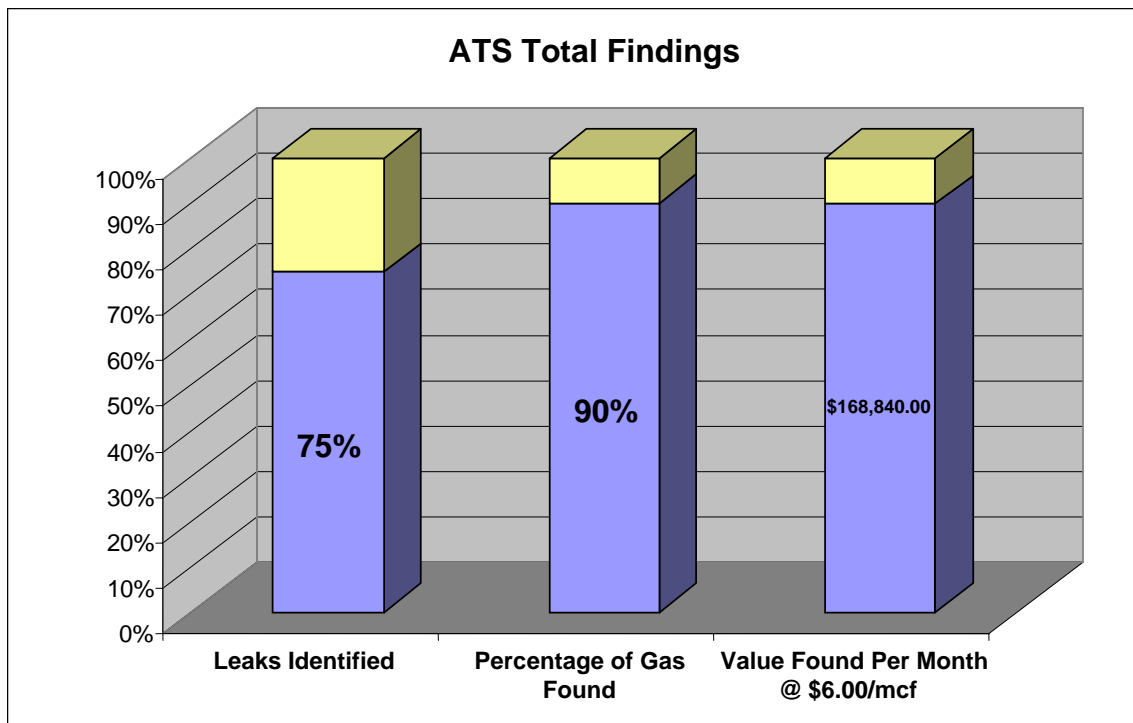
Figure 5. Test Results

The ATS helicopter-based system consistently detected methane leak rates of 500, 100, 10-15, and 1.8 scfh. These leaks were each detected an average of 75% of the time including the 1.8 scfh leak, Figure 5. Ninety (90) % of all emitted gas volume was detected. Few false positive and false negative leaks were identified. The system had no “down-time” and remained operational throughout the three-day test.

Previous tests at the same site conducted under the same scientific conditions with various gas detection systems utilizing automobile, helicopter, or fixed wing aircraft produced the following results: leak rates of 500 scfh or higher were detected 50% of the time; leak rates of 100 scfh were detected 15% of the time; leak rates of 10 - 15 scfh were detected 5% of the time; and the 1.8 scfh leak was never detected.
